EGG-TMI-7429

TMI-2 LOWER PLENUM VIDEO DATA SUMMARY

Published July 1987

EG&G Idaho, Inc.  
Idaho Falls, Idaho 83415

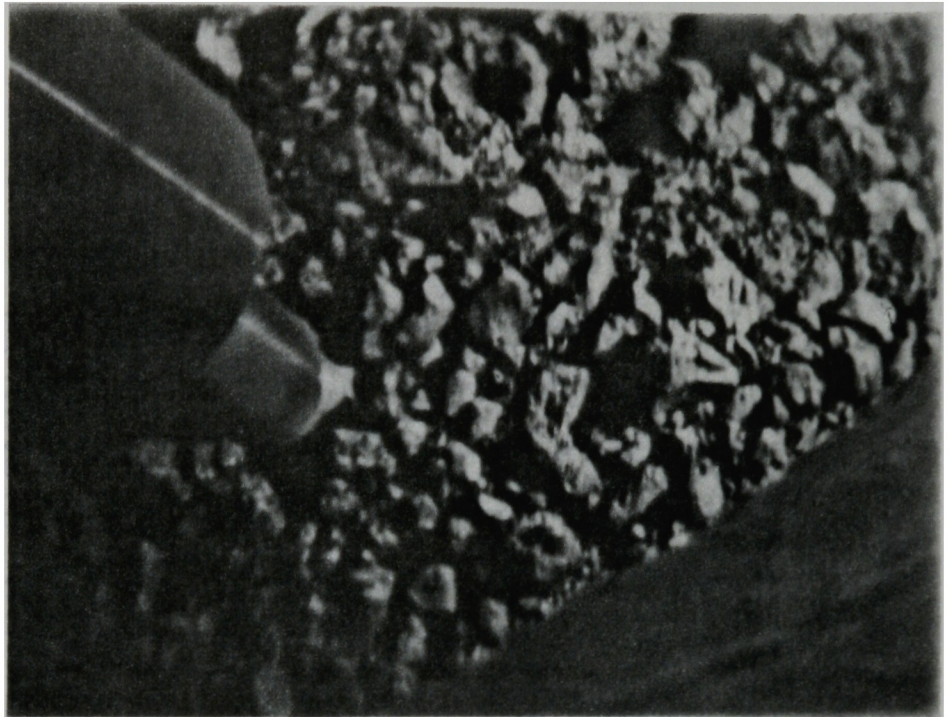
Figure 7. Photograph of TMI-2 lower plenum rubble bed at W axis.

The W axis debris bed looks like a uniform bed of fine to medium-sized debris (see Figure 7). A few larger chunks also exist, but the sizes of these chunks are not determined. There is a transition zone in this region, with a sharp transition between a very uniform and smooth rubble bed and a bed with a large number of medium-sized chunks. The rubble is easily dislodged by the camera and lights. Figures 32 and 33 are photographs of each side of this transition zone.

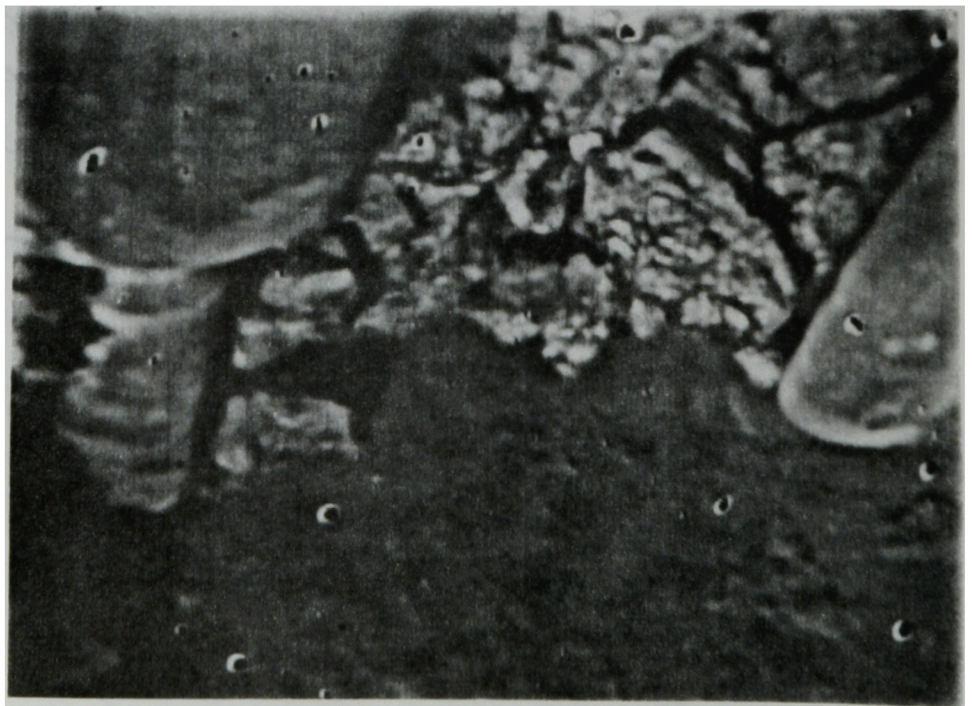
Figure 8. Photograph of TMI-2 lower plenum rubble bed at Y axis.

Large differences in physical appearance exist in the rubble bed. The rubble near the Y axis, as indicated earlier, has the appearance of a large, lava-like cliff which abuts the outermost row of instrument guide tubes (see Figure 8). The region in front of the rubble cliff has almost no debris. In some places, the lower head can be seen, indicating only a light "dusting" of debris at this location. The cliff appears to be solid with a smooth surface interlaced with cracks. There are also some large chunks of previously molten corium which may be loose.

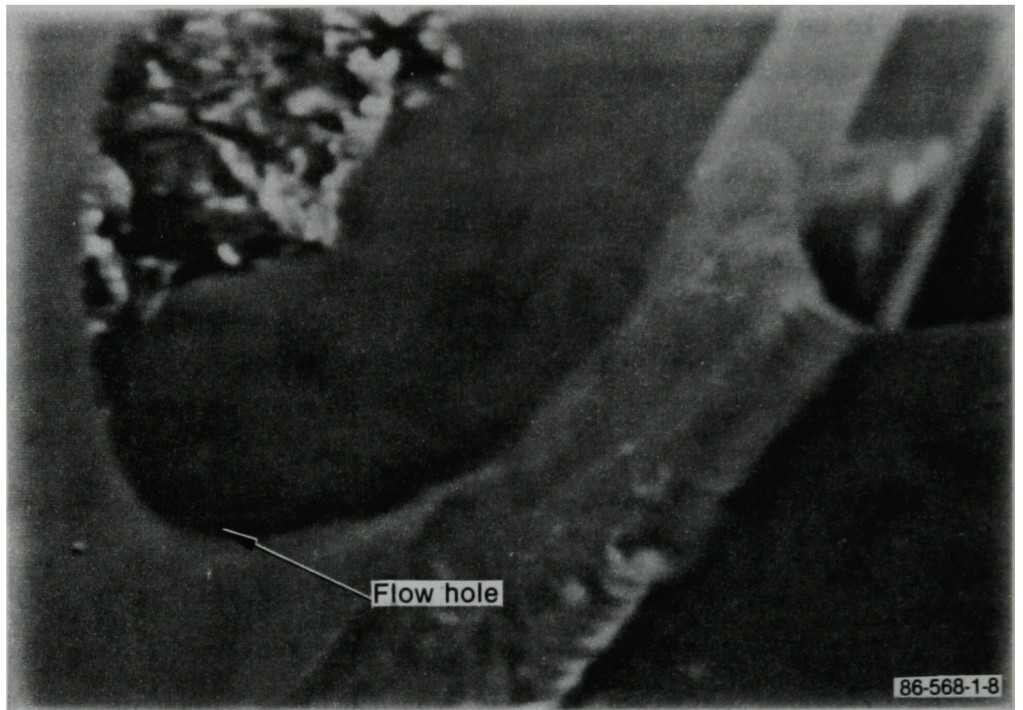
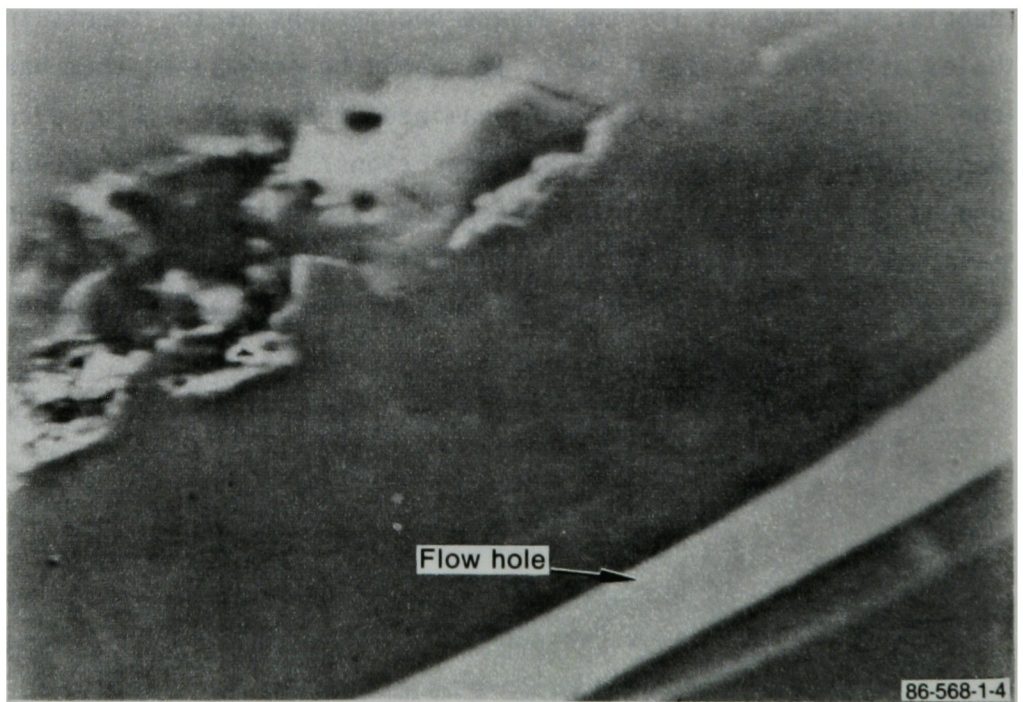
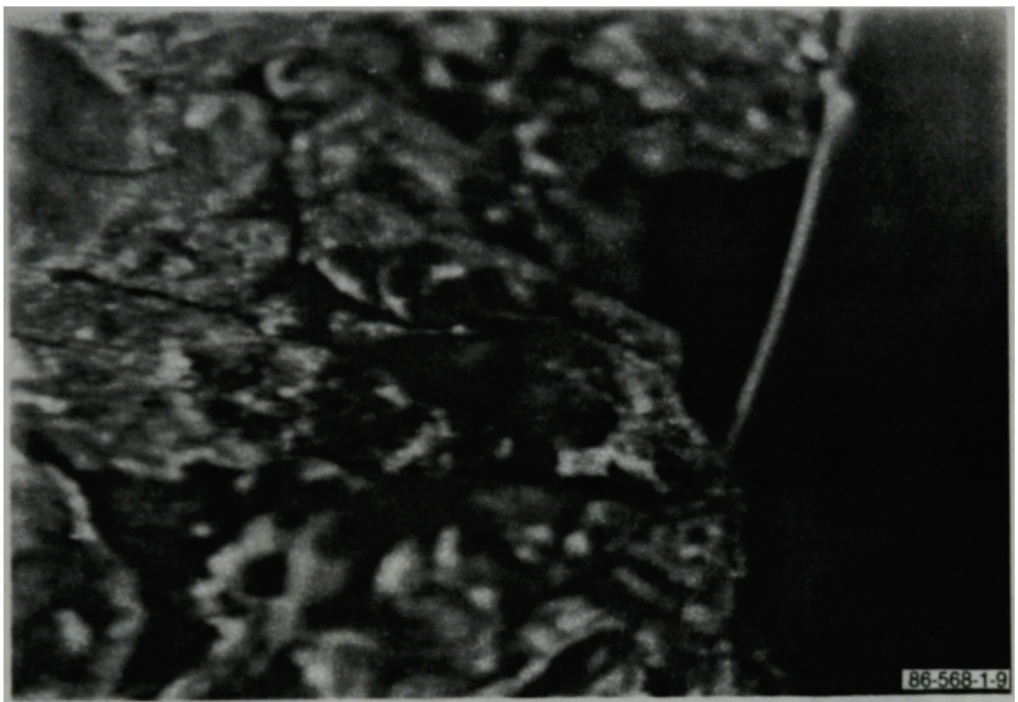
During the lower plenum inspection, debris was observed in some of the holes in the elliptical flow distributor head. The debris in this region was mainly observed during the February 1985 inspection of the Z axis (hole No. 4), the December 1985 inspection of the Y axis (hole No. 14), and the December 1985 inspection of the W axis (hole No. 7). The region of inspection (of the elliptical flow distributor head) was very limited, and no attempt has been made to map the region where debris has been observed. Enhanced photographs were made from the video tapes to illustrate this debris. Figures 26 through 28 are photographs of the debris in the flow holes at different locations. It should be emphasized that only a part of the flow distributor plate was examined due to the lack of a camera manipulator during some of the inspections. Also, since the core was broken up due to the drilling operations, causing additional debris to be relocated to the CSA, it will be difficult, if not impossible, to determine the condition of this head after the accident by additional inspections.

Figure 26. Photographs of TMI-2 debris in flow hole at Z axis.

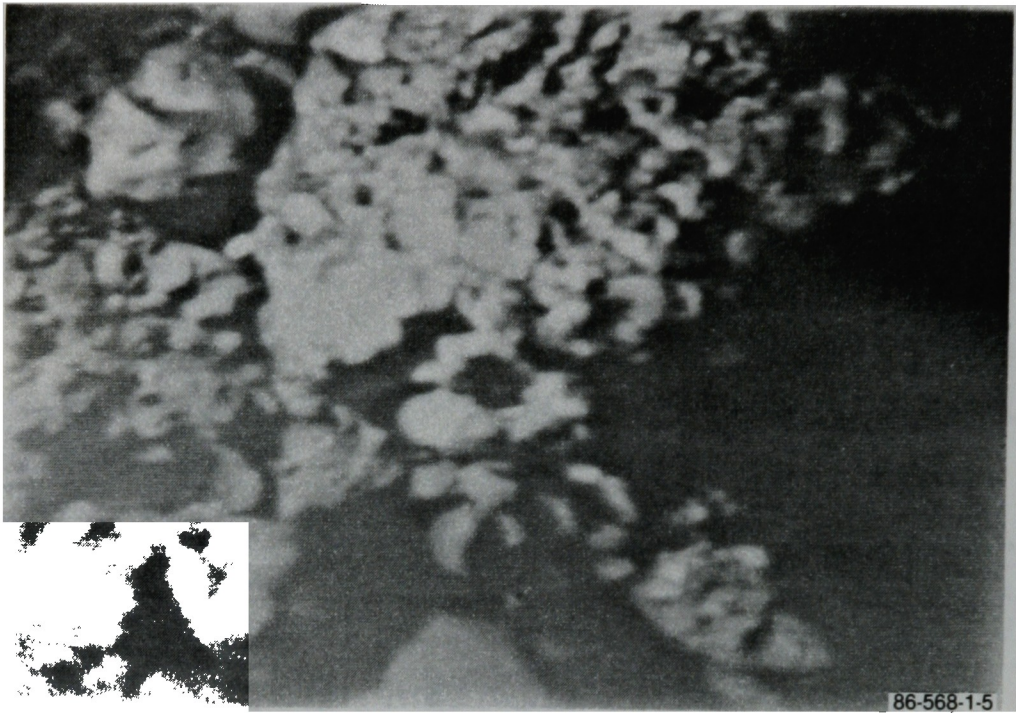
**Figure 27. Photograph of TMI-2 debris on top of elliptical flow distributor plate.**

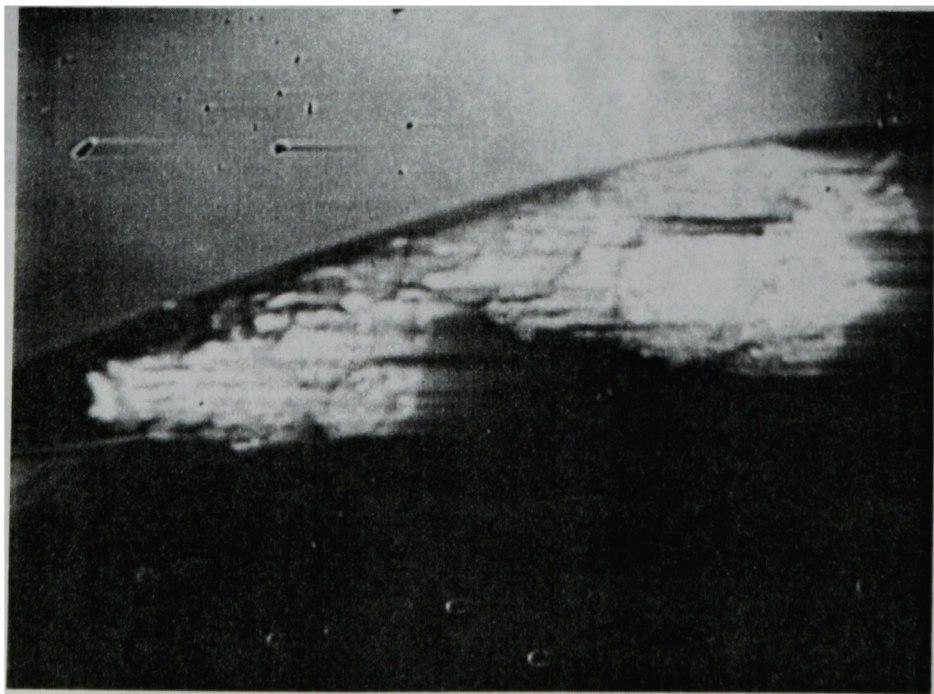
**Figure 28. Photograph showing previously molten corium in flow hole at W axis.**

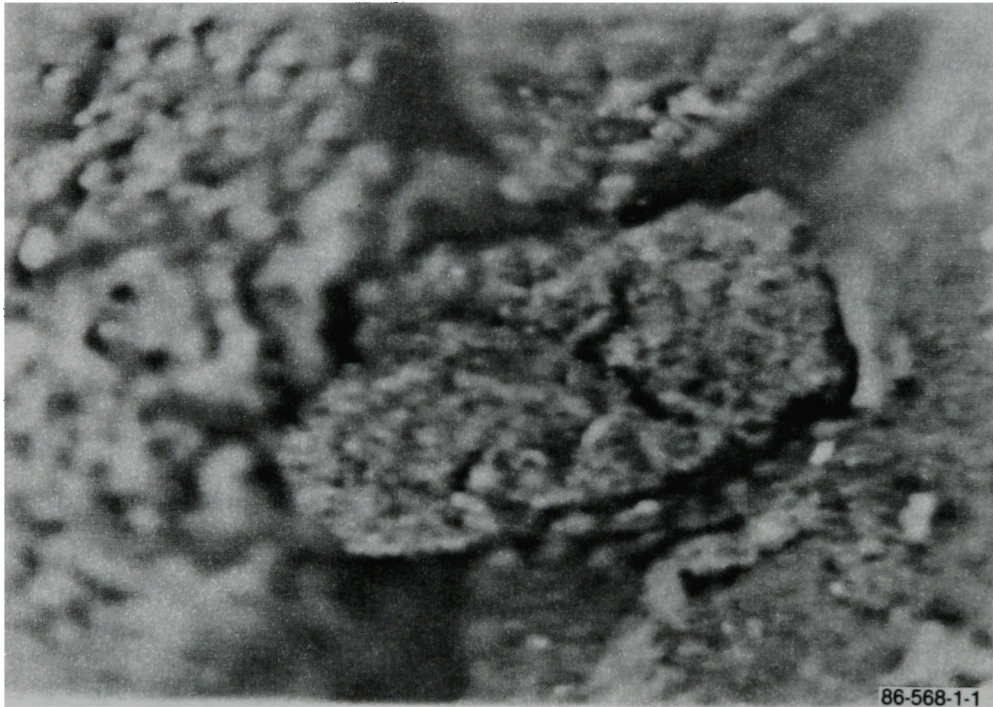
The rubble near the X axis has a large number of 2- to 5-cm-sized chunks interspersed with much finer material. This is illustrated by the photograph of this area shown in Figure 29.

Figure 29. Photograph of large TMI-2 debris chunk at X axis.

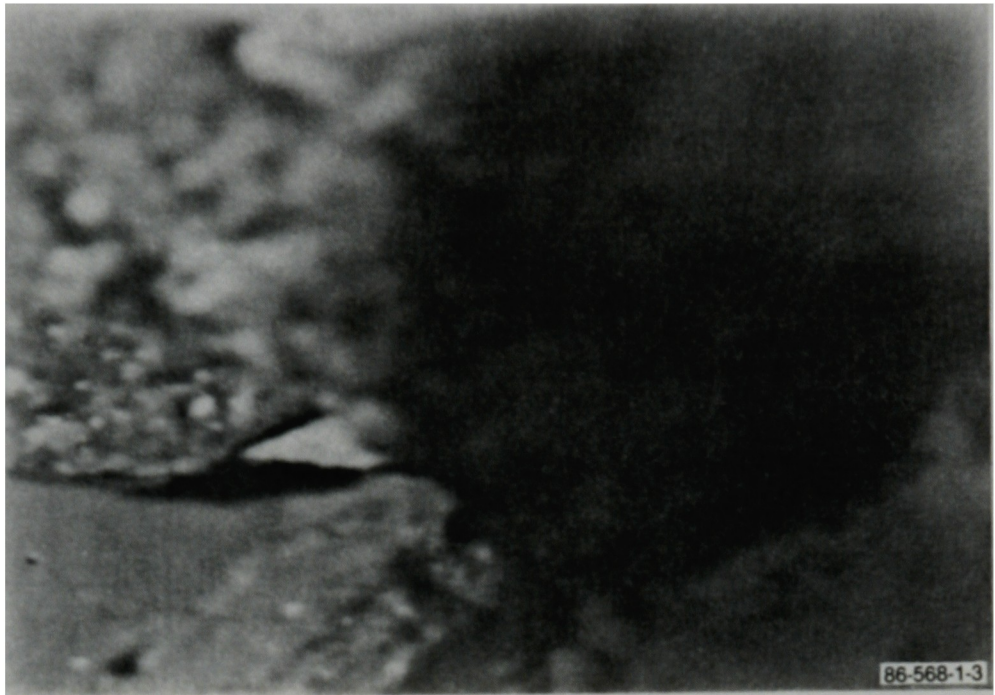
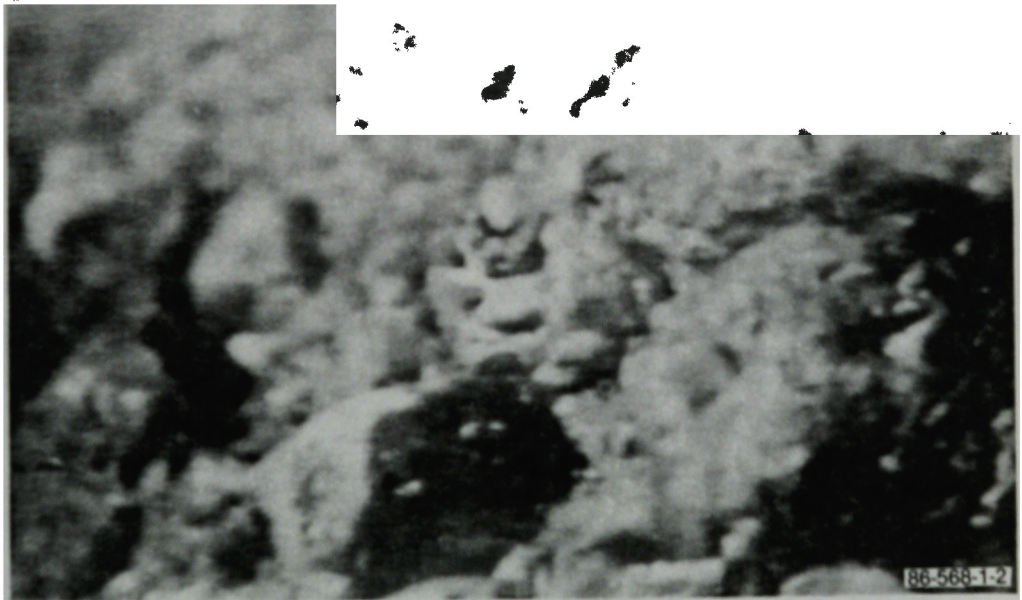
The Z axis appeared to have the largest chunks. At least one chunk is estimated to be 15 to 20 cm in size. Several other large (7 cm or larger) chunks also are present. The larger pieces look porous, with small cracks and smooth surfaces. Figures 30 and 31 illustrate the coarseness of the debris bed in this region.

Figure 30. Photographs of large TMI-2 debris chunks at Z axis.

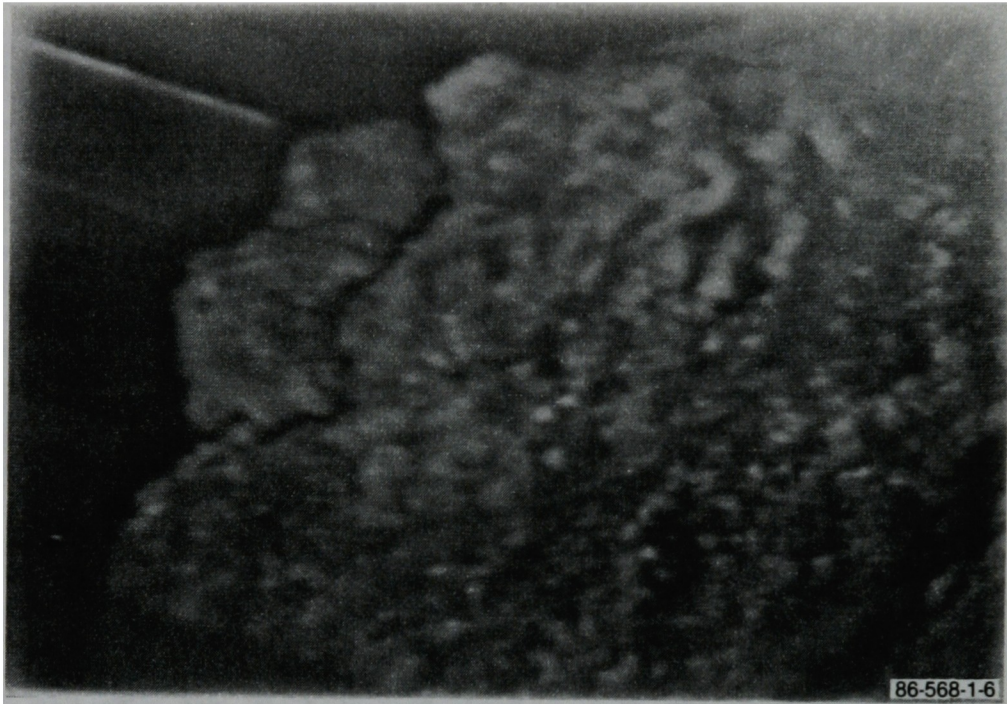
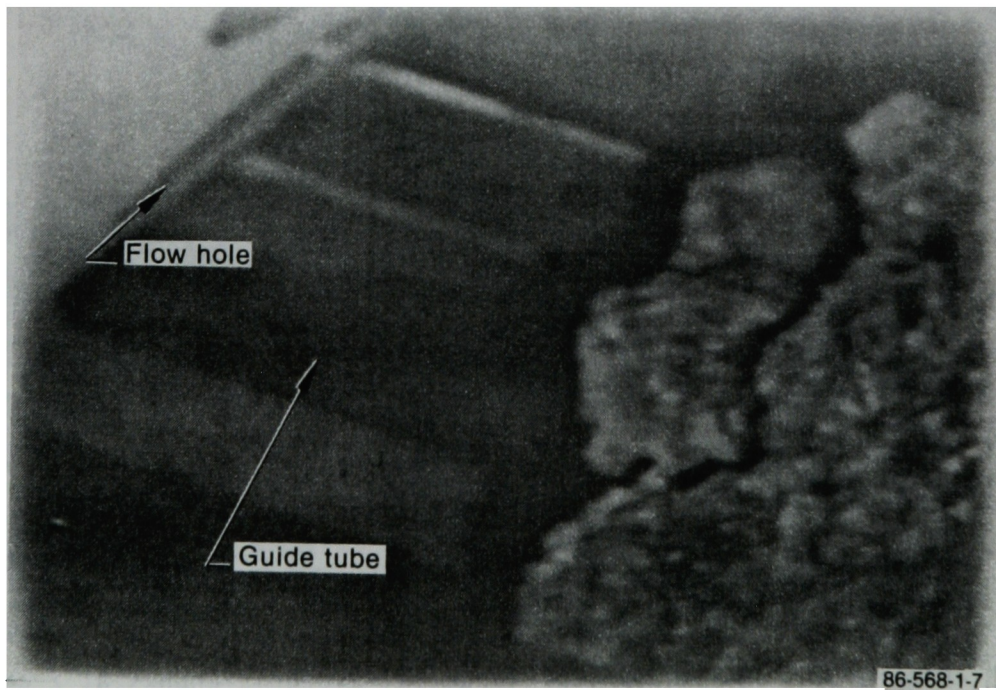
Figure 31. Photographs showing TMI-2 debris chunks in relation to instrumentation guide tube at Z axis.

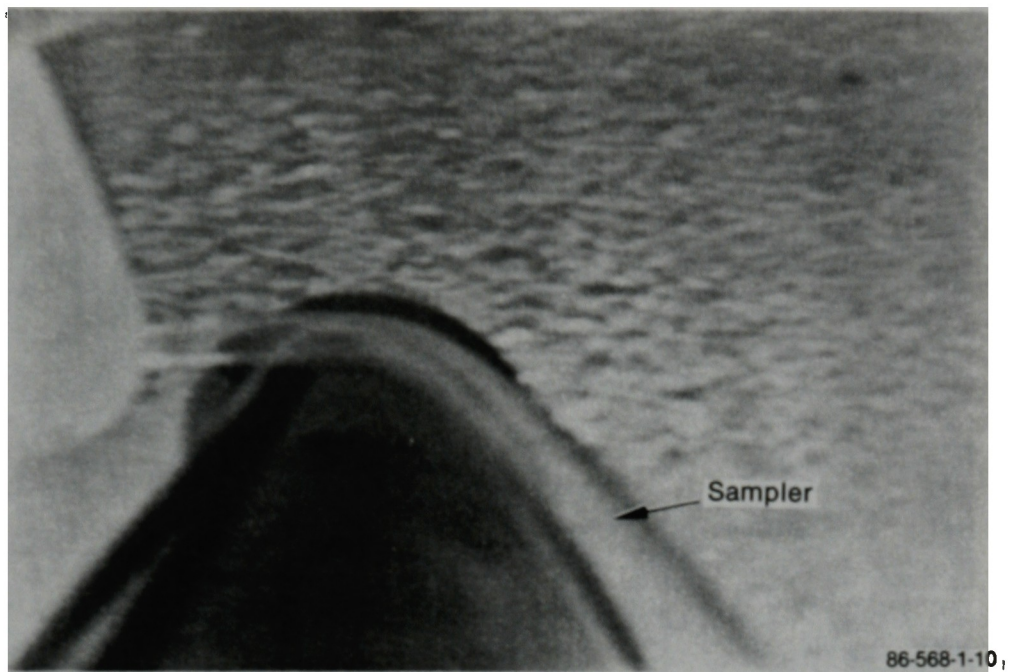
**Figure 32. Photograph showing smooth TMI-2 debris surface at W axis.**

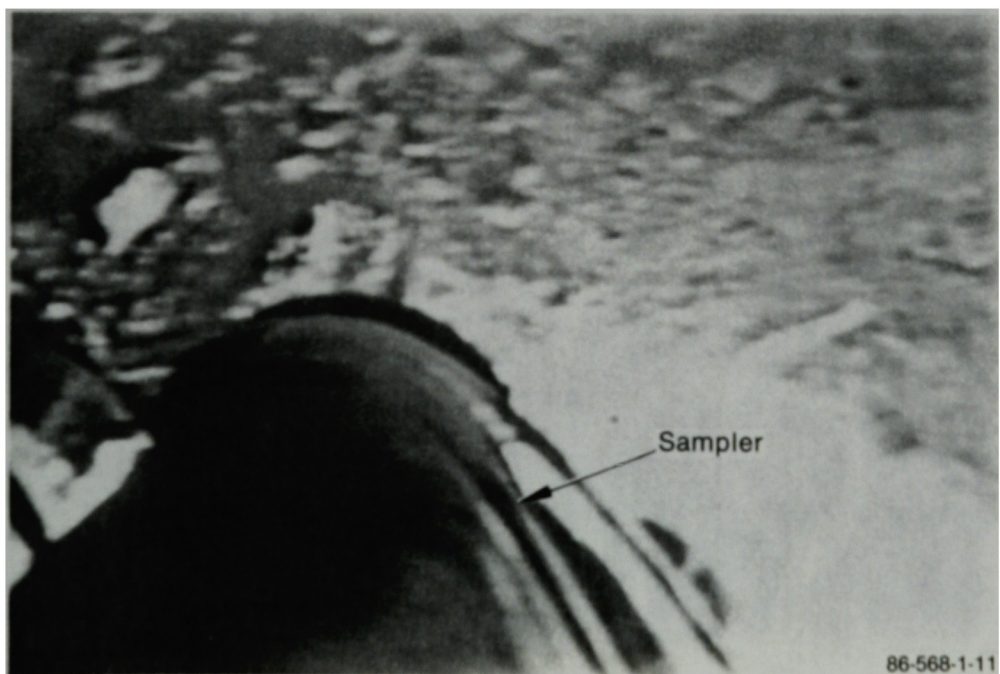
**Figure 33. Photograph showing coarse TMI-2 debris on top of smooth surface at W axis.**

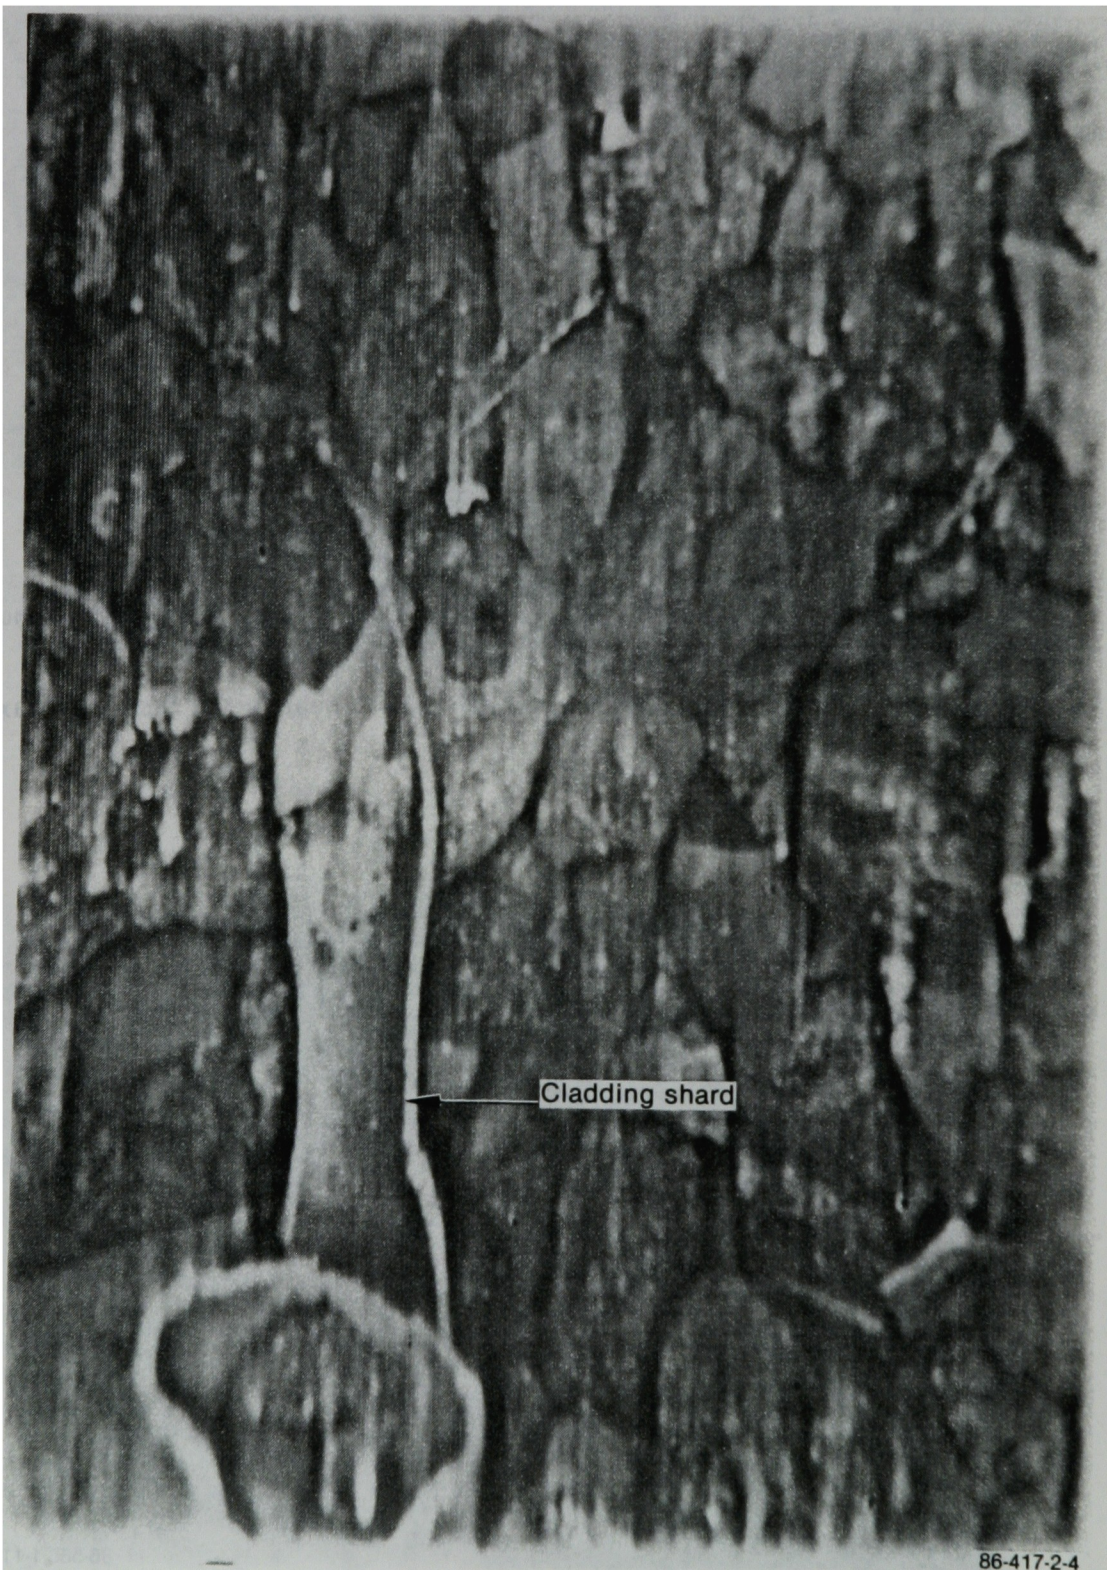
Figure 34. Photograph of TMI-2 lower plenum debris bed at the K-9 location.

the K-9 location and includes cladding shards which most probably relocated there during the operation. An estimate of the relative sizes of the rubble can be made by comparison with the shard which lies atop the bed (diameter approximately 2.5 cm). As was the case at the W axis, the rubble appears to be very loose and is easily dislodged by the camera.

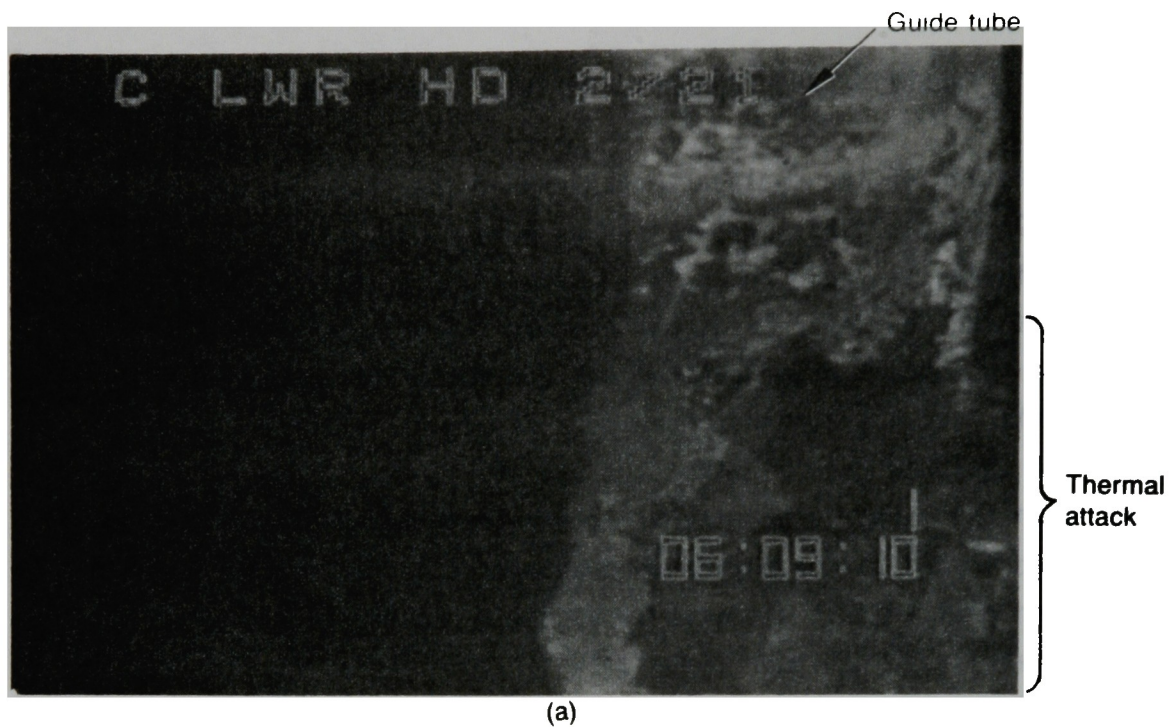
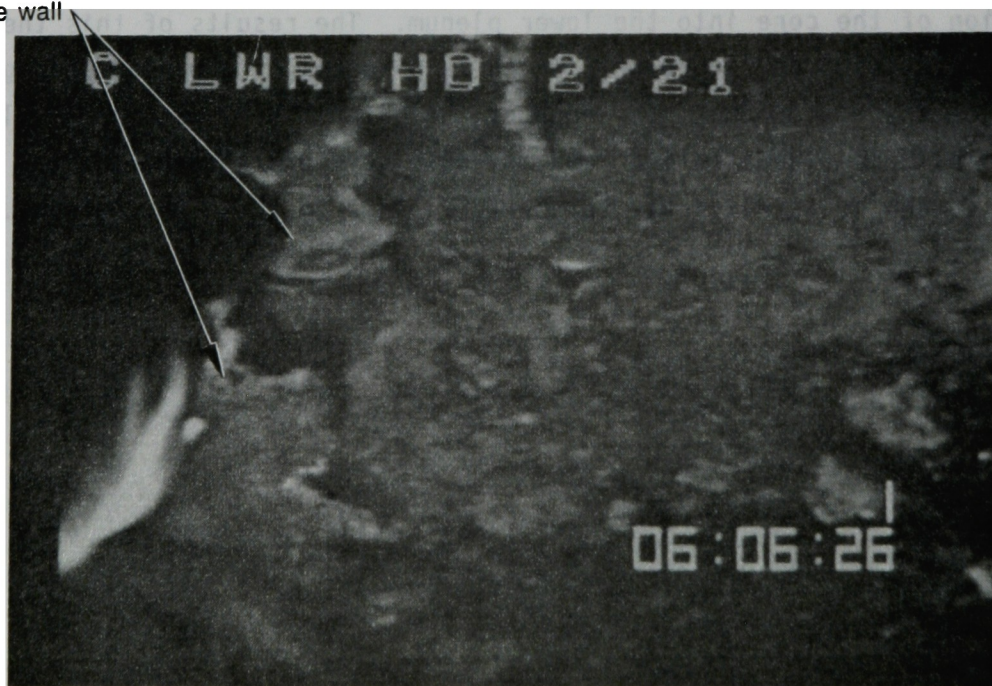
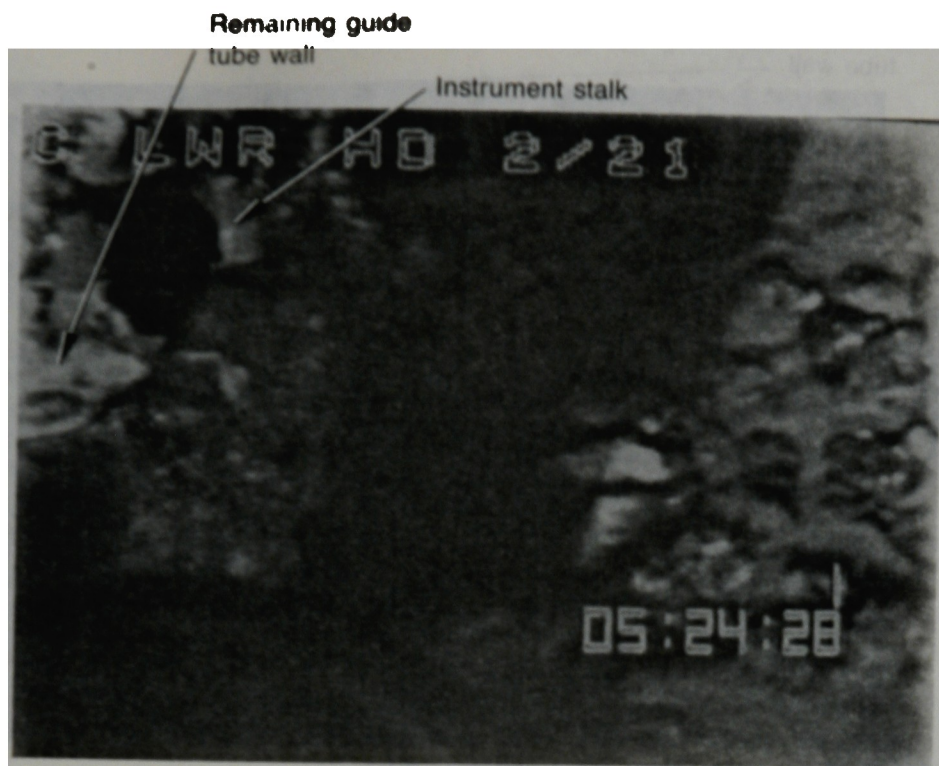
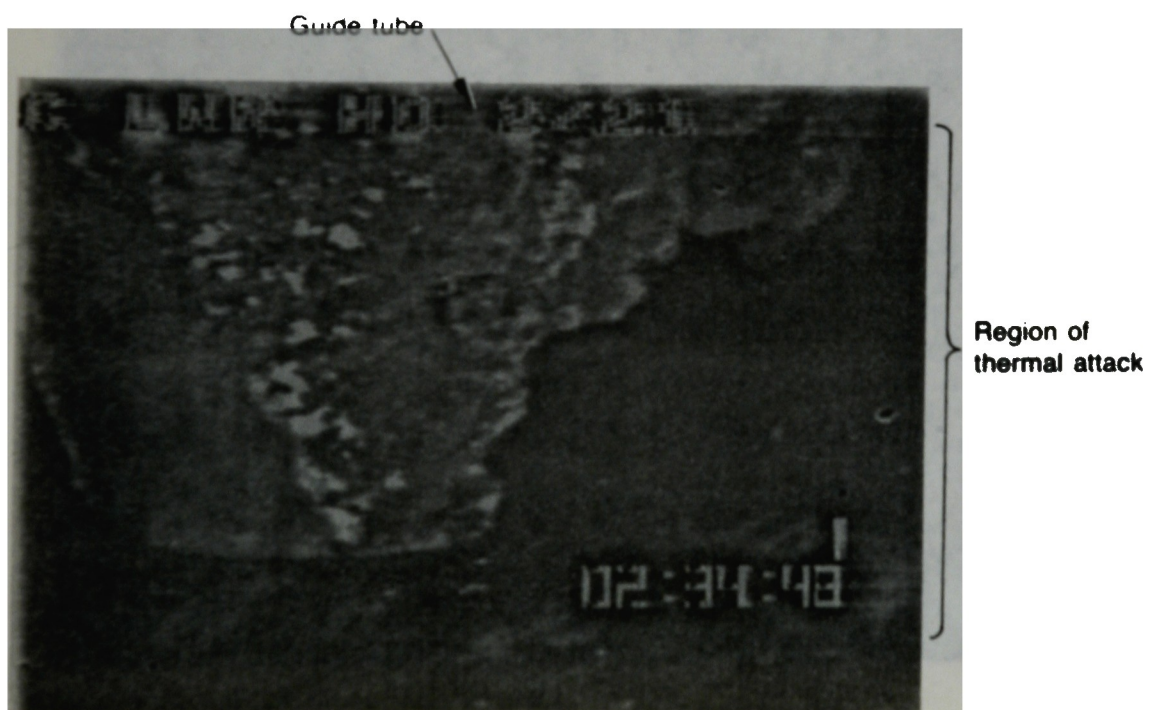
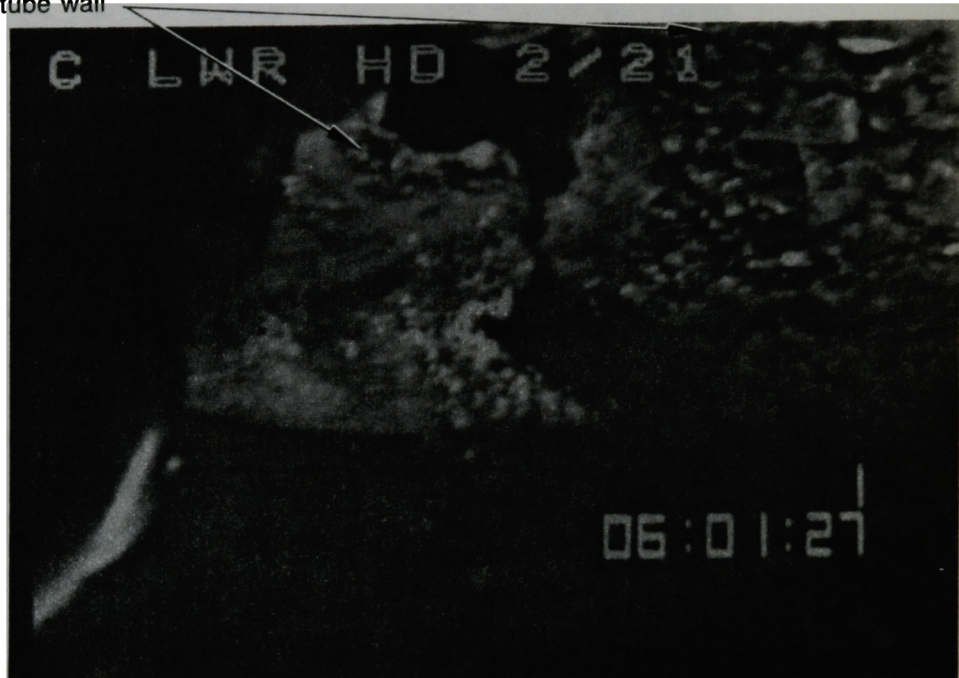
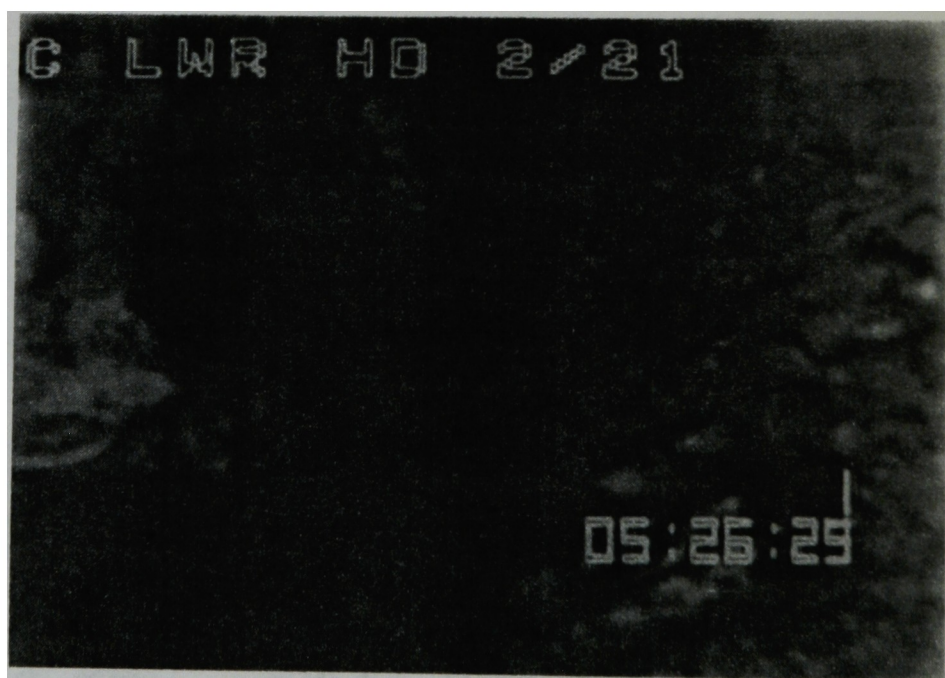
Figure B-1. Enhanced photograph of guide tube #45, core position R-7.

The condition of guide tube 45 was clearly visible during the inspection. This guide tube experienced thermal attack during the relocation of the core into the lower plenum. The results of this thermal attack are evident on Figure B-1, which is a series of enhanced photographs taken from the video data. The edge of the guide tube is severely ablated, and the instrument penetration tube may also have experienced thermal attack, though it is difficult to see the latter in these photographs.

Remaining guide  
tube wall
